# Manhole Inspection Summary

Manhole # S35Q\_\_039MH

**Location** Address: **1034 s. hanover st**

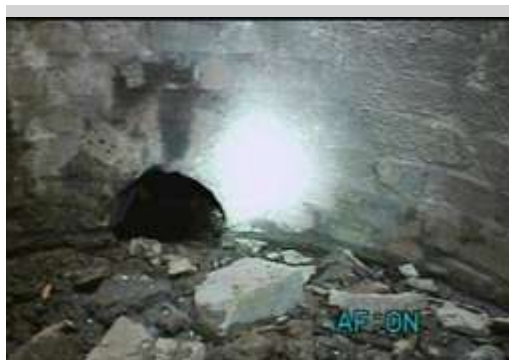
Defect 4

Condition: ☐ Sound ☐ Cracked ☐ Root Intrusion ☐ Deteriorated ☐ Leaks ☒ **Debris**

channel debris

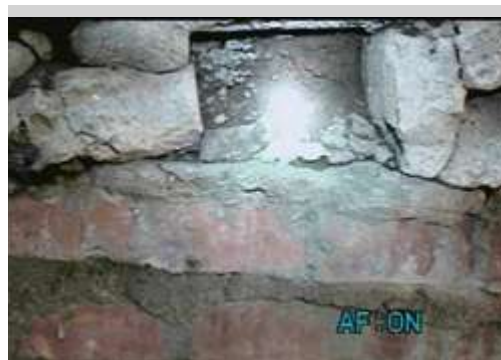
Defect 3

Condition: ☐ Sound ☒ **Cracked** ☐ Root Intrusion ☒ **Loose Brick** ☒ **Deteriorated**

chimney cracked, loose bricks,  
deteriorating, Frame Adjustment

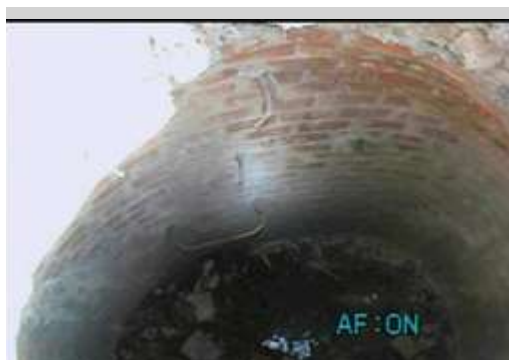
Defect 2

Count: **3** Missing: **2** ☒ **Corroded**

Steps corroded/missing

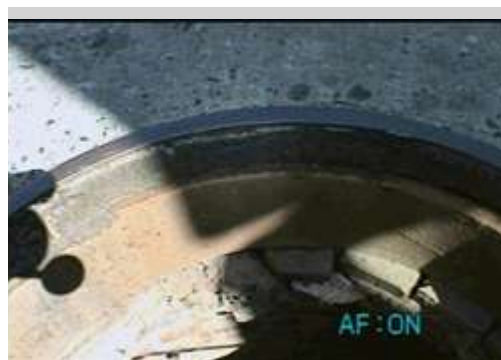
Defect 1

Offset: **1** (in.)

offset
